UNITED STATES ENVIRONMENTAL PROTECTION AGENCY

SUBJECT: Inspection Report Transmittal to Ledgeview Farms, LLC

On April 9, 2015, EPA conducted an inspection of your facility, Ledgeview Farms in De Pere, Wisconsin. The purpose of the inspection was to evaluate compliance with the Clean Water Act (CWA) and Administrative Order V-W-13-AO-22. Ledgeview Farms is a large Concentrated Animal Feeding Operation (CAFO) as defined in 40 C.F.R. § 122. During the inspection, we observed violations of the CWA and Administrative Order. The CWA and Order requires you to immediately cease all unauthorized discharges.

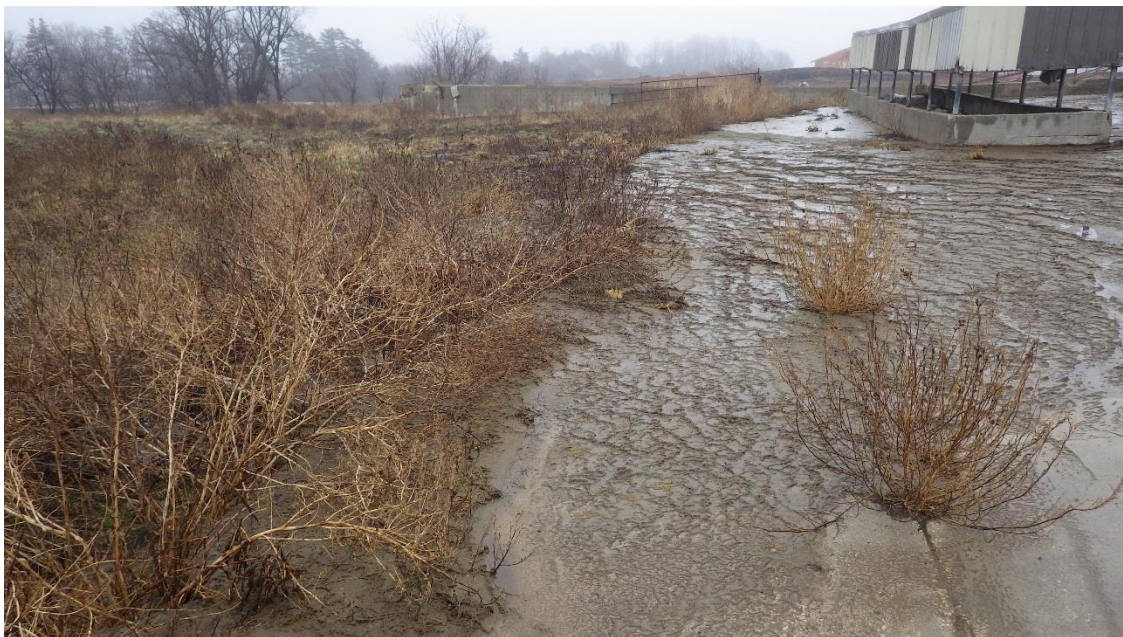
50: RIMG0059

Description: Manure solids and process wastewater flowed off the concrete into the field west of the concrete pits. The manure and process wastewater was emanating from the New Barn, the barn west of the New Barn, and the access ways between these barns.

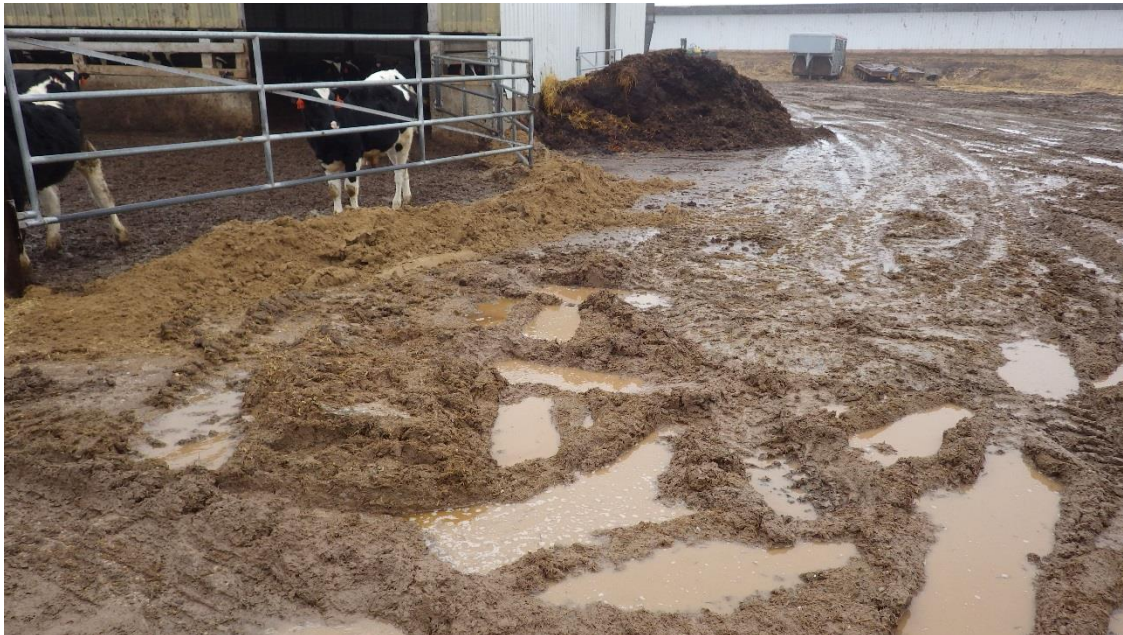
54: RIMG0063

We walked to Lot B. The open lot did not have containment for manure or process wastewater. A sand berm had recently been placed on the east end of the open lot (Attachment 2: RIMG0063-RIMG0064). A pile of bedding was located at the east side of Lot B. The process wastewater from the open lot and pile could flow east and north to a culvert under the New Barn and to the unnamed tributary on the east side of the site (Attachment 2: RIMG0064-RIMG0065). I observed a pile of waste material located east of Lot B (Attachment 2: RIMG0066-RIMG0067). Process wastewater contacting the waste material could flow north to the culvert under the new barn and to the unnamed tributary.

Description: A stockpile of bedding material was located east of Calf Barn 2. A sand berm was placed on the east end of Calf Barn 2. The process wastewater from the open lot and pile could flow east and north to a culvert under the New Barn and to unnamed tributary on the east side of the site.

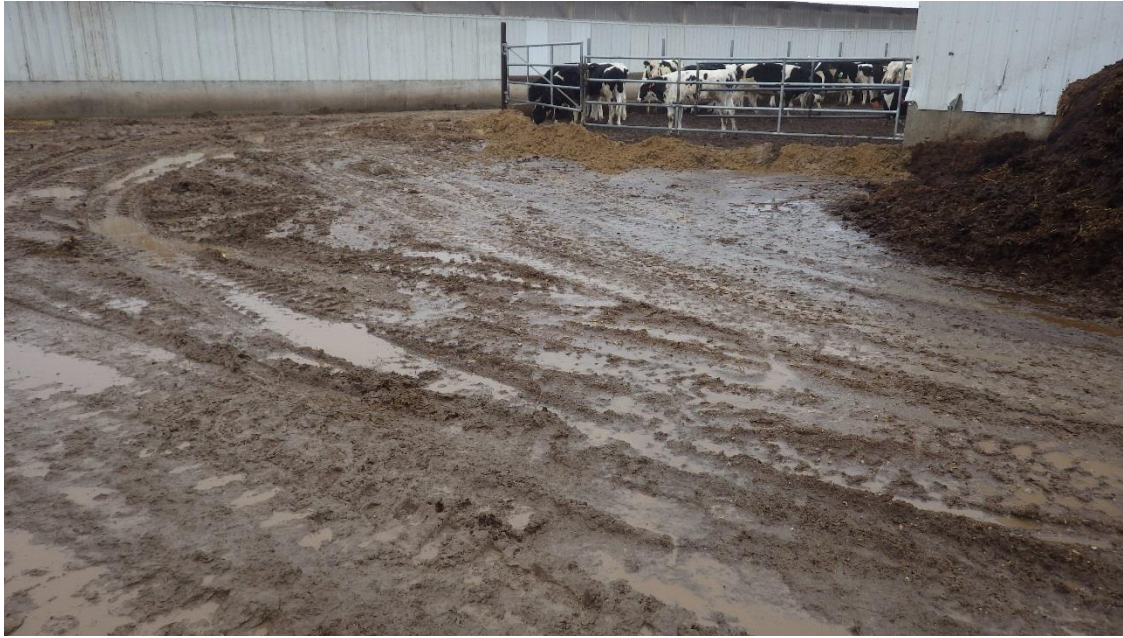
55: RIMG0064

Description: A stockpile of bedding material was located east of Calf Barn 2. A sand berm was placed on the east end of Calf Barn 2. The process wastewater from the open lot and pile could flow east and north to a culvert under the New Barn and to the unnamed tributary on the east side of the site.

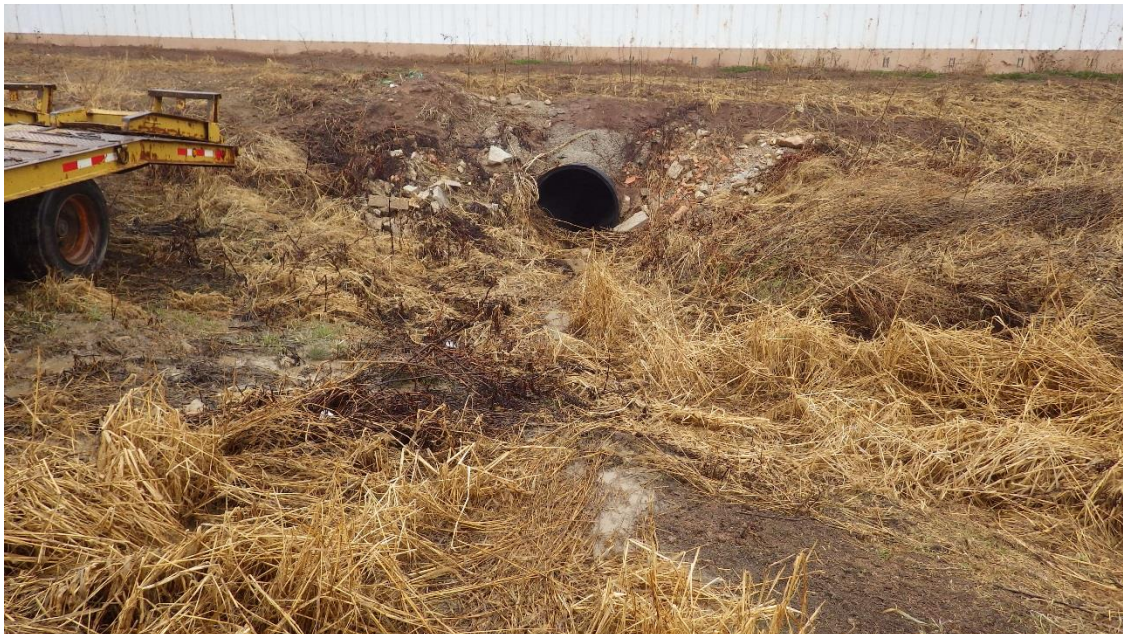
56: RIMG0065

Description: The culvert inlet under the New Barn.

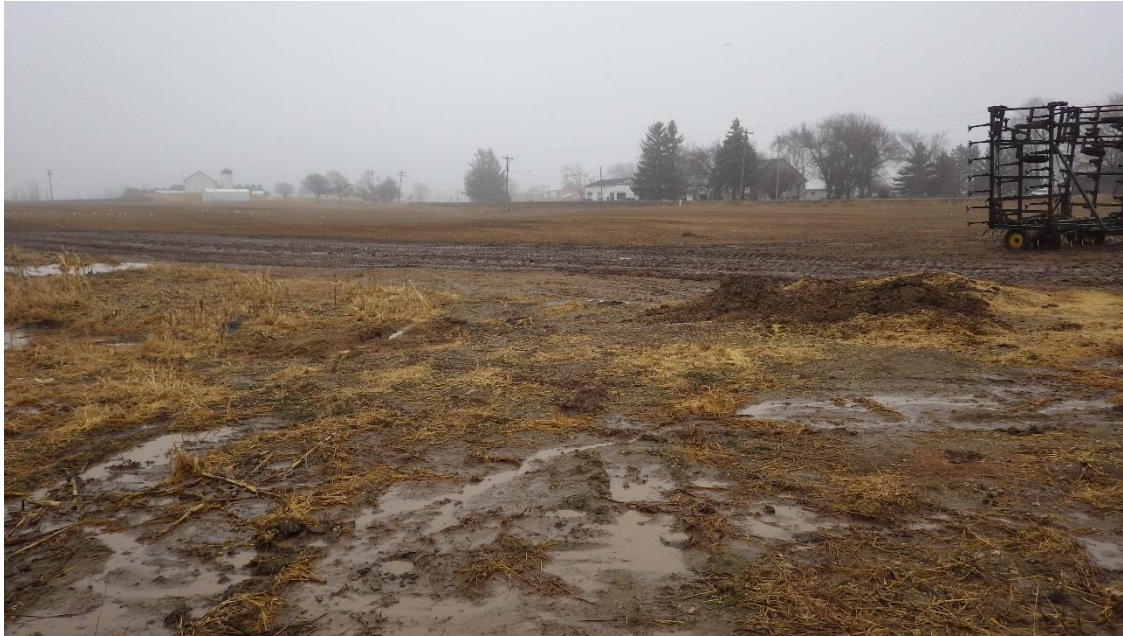
57: RIMG0066

Description: A pile of waste material was placed such that process wastewater generated from it would flow to the culvert under the New Barn which flows to the unnamed tributary on the east side of the site.

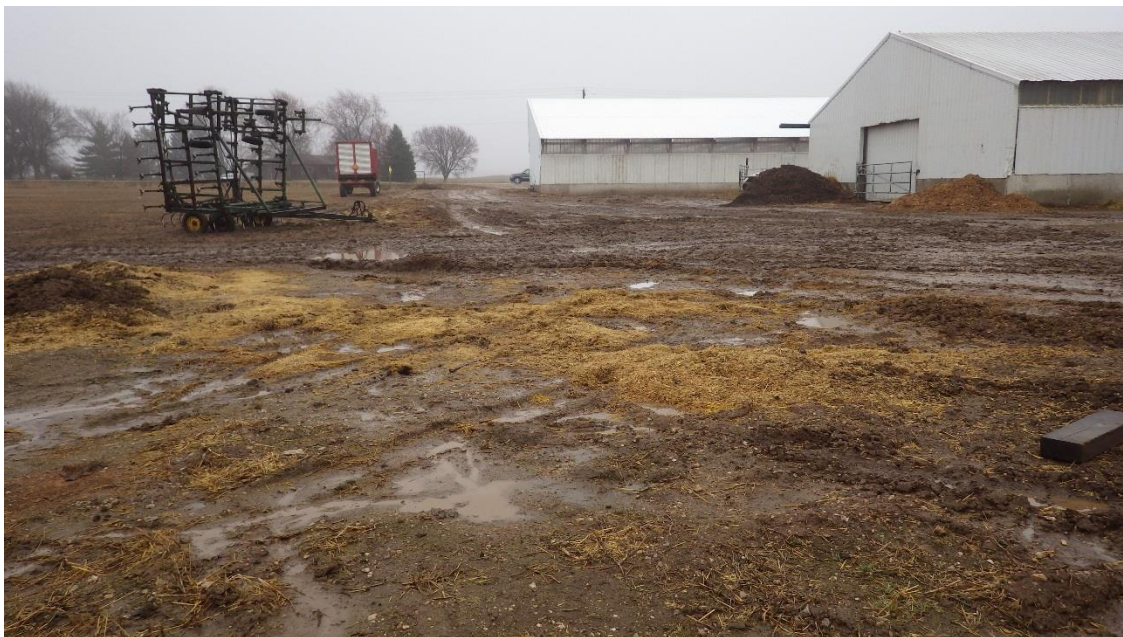
58: RIMG0067

Description: A pile of waste material was placed such that process wastewater generated from it would flow to the culvert under the New Barn which flows to the unnamed tributary on the east side of the site.

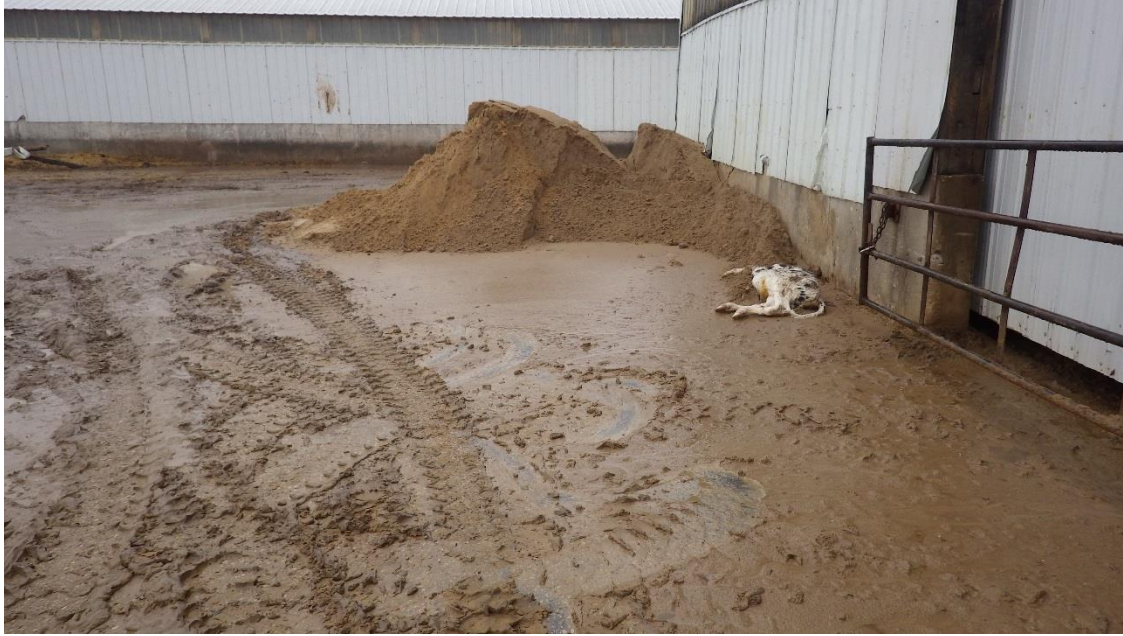
59: RIMG0068

Description: A pile of sand and dead calf.

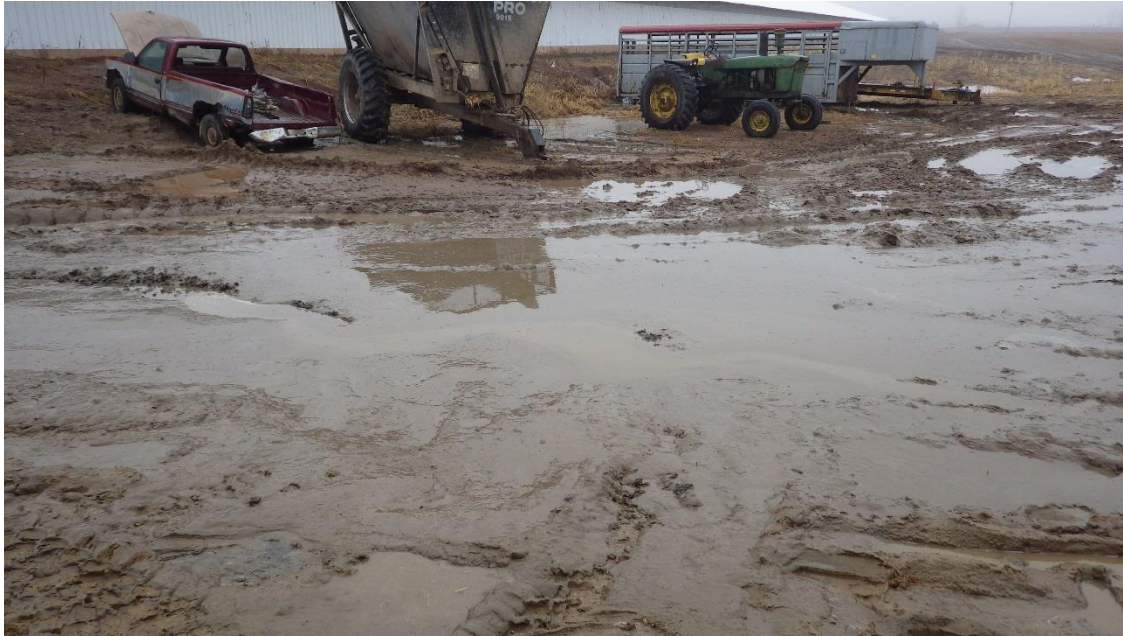
60: RIMG0069

Description: A mucky area drains toward the culvert under the New Barn.

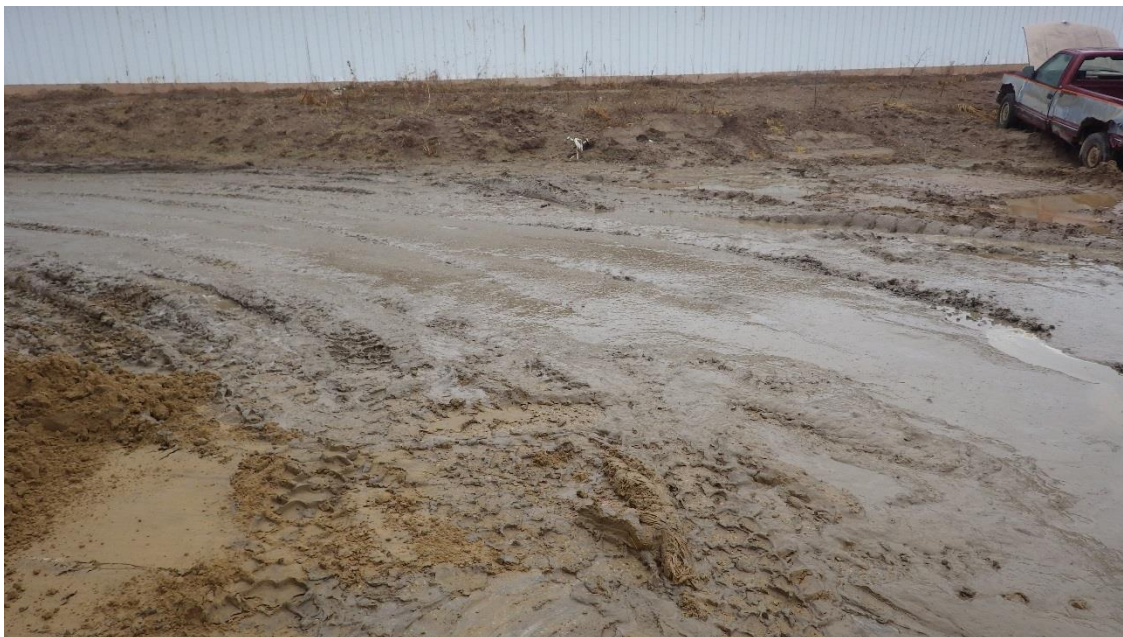
61: RIMG0070

Description: A mucky area drains toward the culvert under the New Barn.

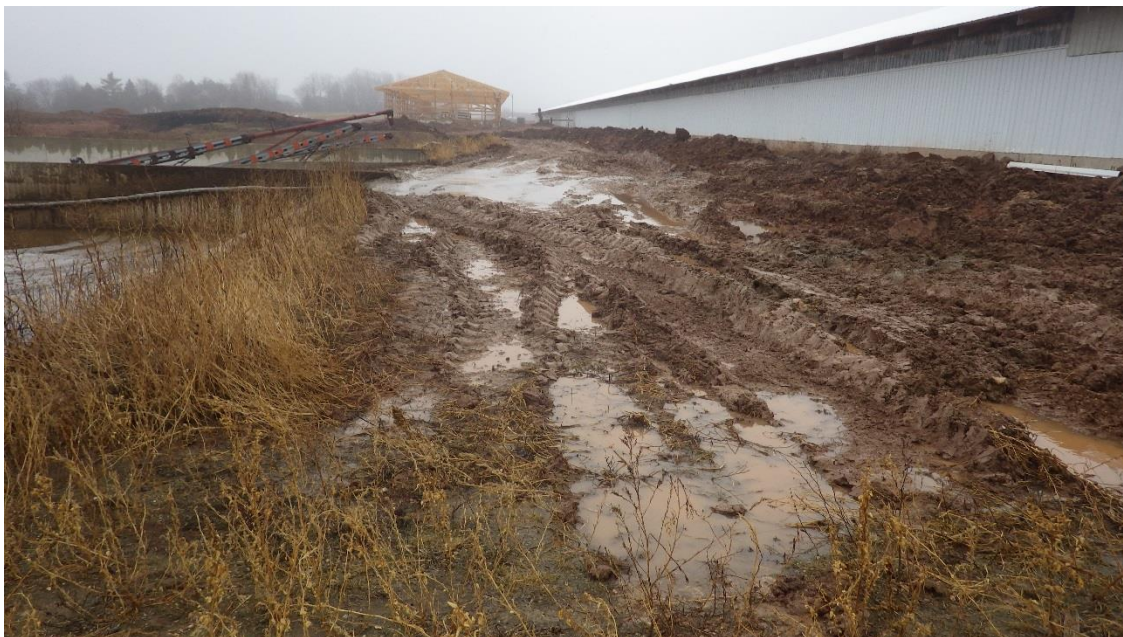
69: RIMG0078

Description: A cow access way between the New Barn and the barn west of the New Barn contained manure solids on its surface and process wastewater flowed north to the field west of the concrete pits.

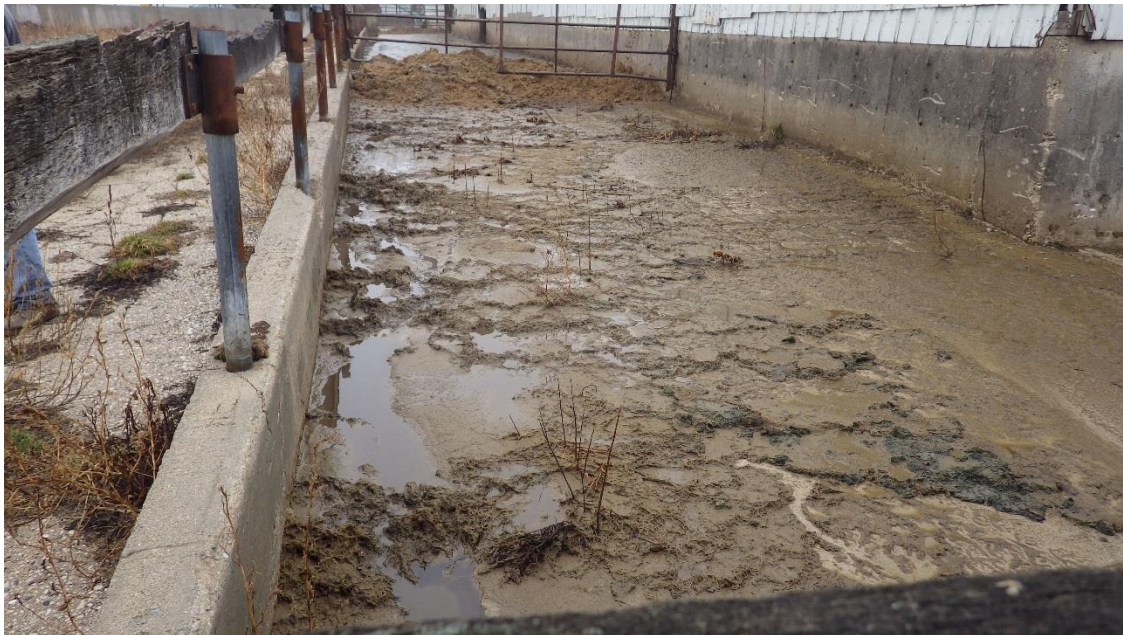
71: RIMG0080

Description: Manure and process wastewater flowed north from the access way between the New Barn and the barn west of the New Barn. It then flowed west after contacting a concrete wall and then flowed to the north into the field west of the concrete pits.

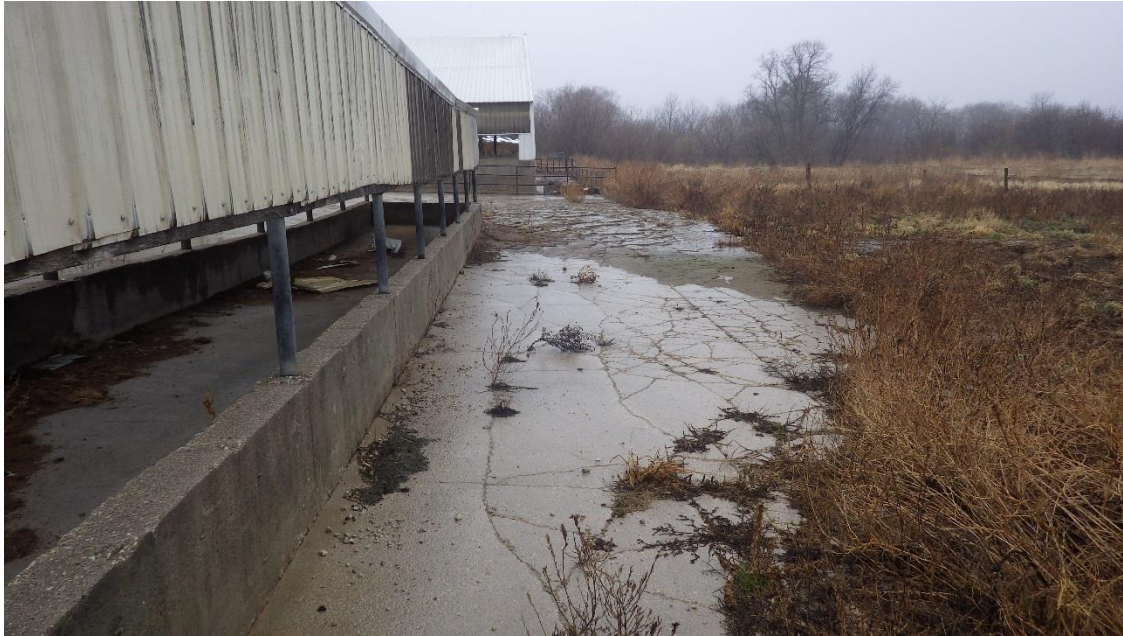
72: RIMG0081

Description: Manure and process wastewater flowed north from the access way between the New Barn and the barn west of the New Barn. It then flowed west after contacting a concrete wall and then flowed to the north into the field west of the concrete pits. A sand berm had recently been placed near the metal gate on the access way.

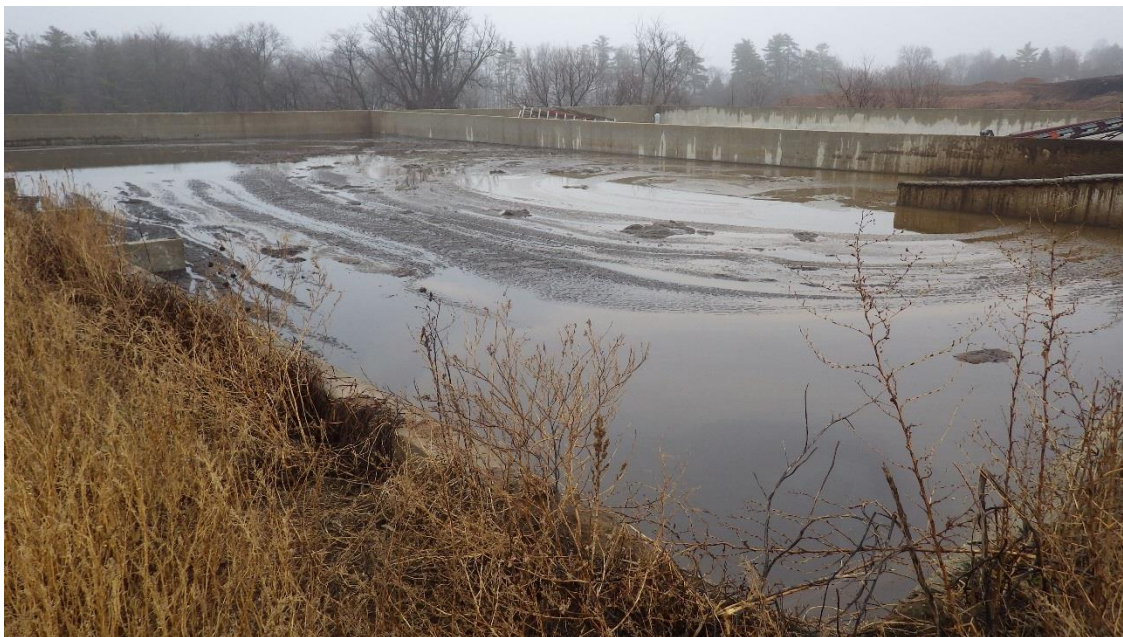
73: RIMG0082

Description: Manure and process wastewater flowed north from the access way between the New Barn and the barn west of the New Barn. It then flowed west after contacting a concrete wall and then flowed to the north into the field west of the concrete pits.

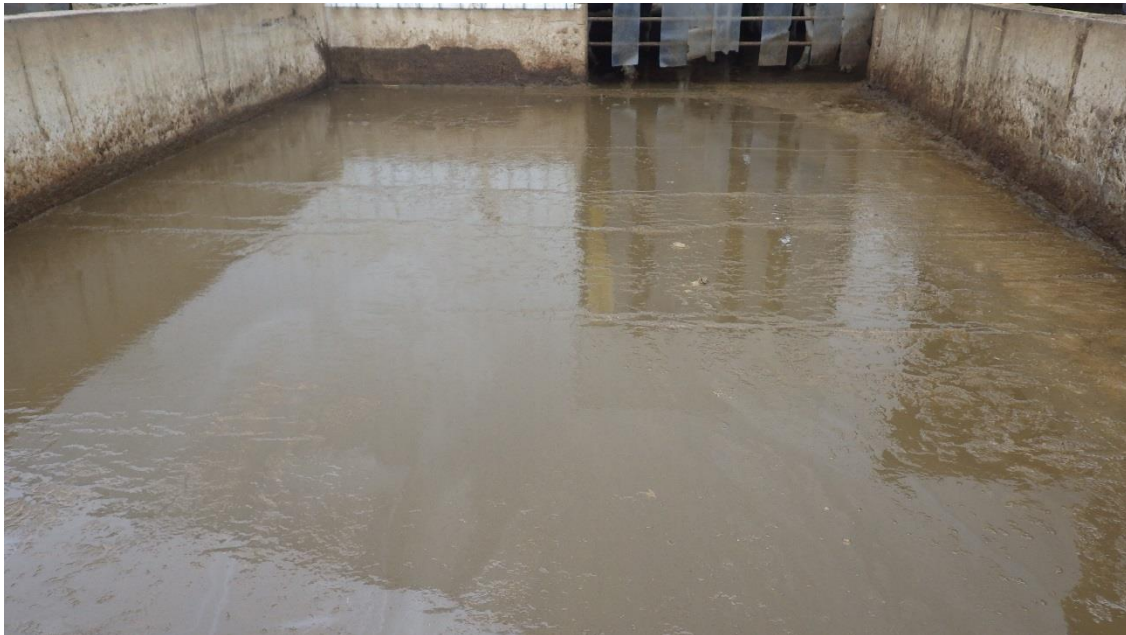
81: RIMG0090

Description: A trickling flow of process wastewater was emanating from the northwest corner of the west concrete pit.

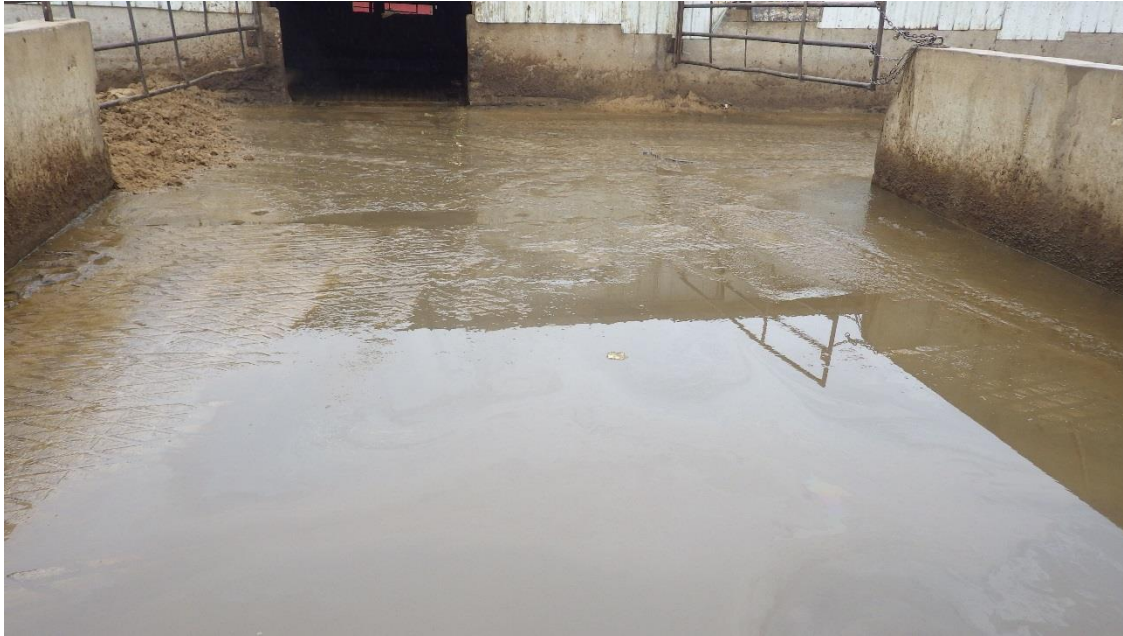
82: RIMG0091

Description: Manure and process wastewater flowed from the new barn and access way west and then north.

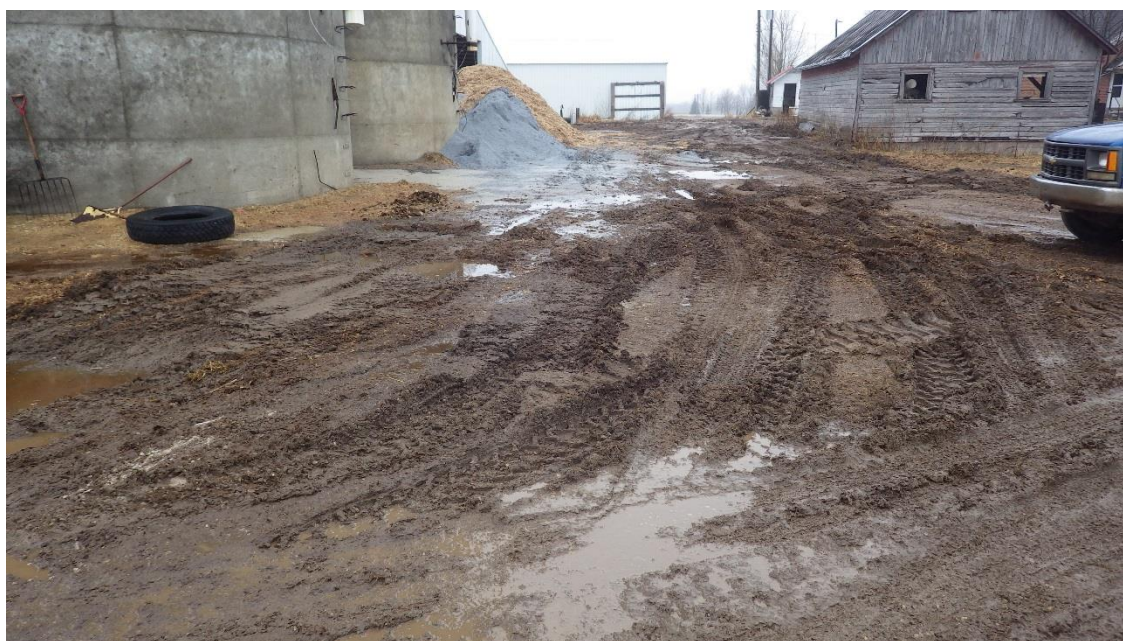
87: RIMG0096

Description: Process wastewater east of Lot D.

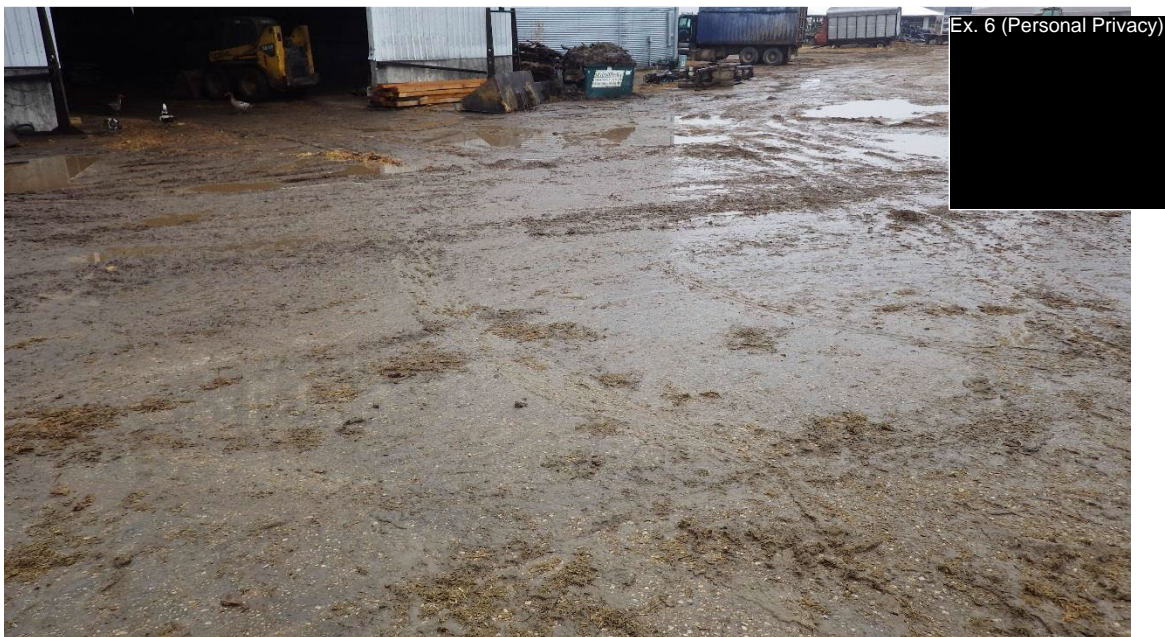
89: RIMG0098

Description: Feed and manure on the concrete east of Lot D.

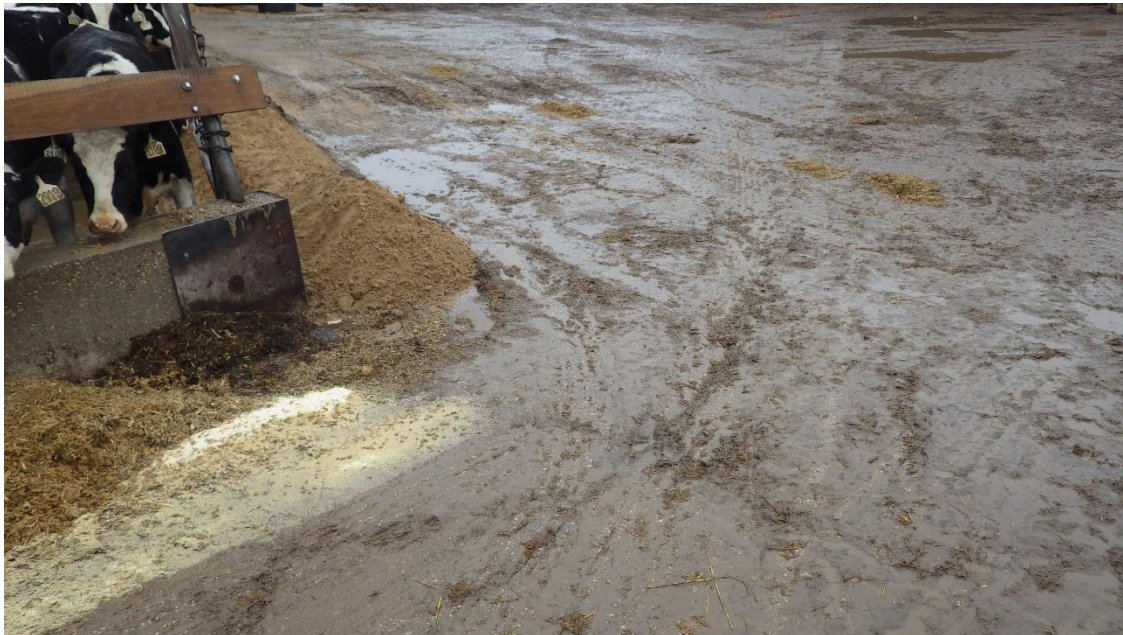
91: RIMG0100

Description: A sand berm had recently been placed at the access gate for Lot D. Manure and process wastewater were observed east of the access gate on the concrete.

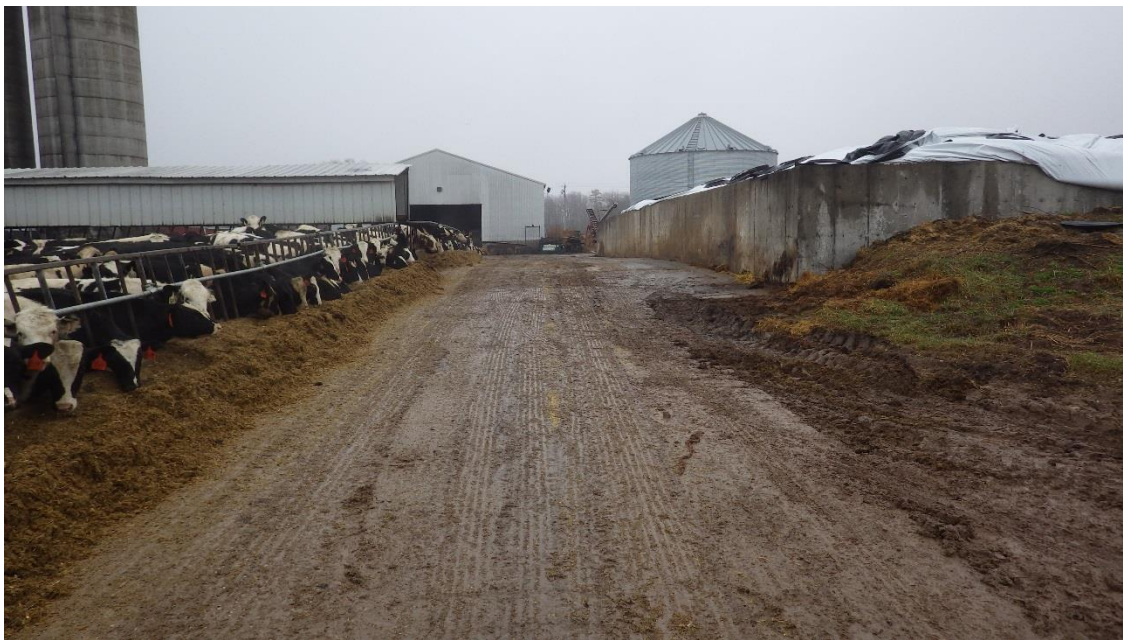
93: RIMG0102

Description: Manure and process wastewater on the concrete east of Lot D.

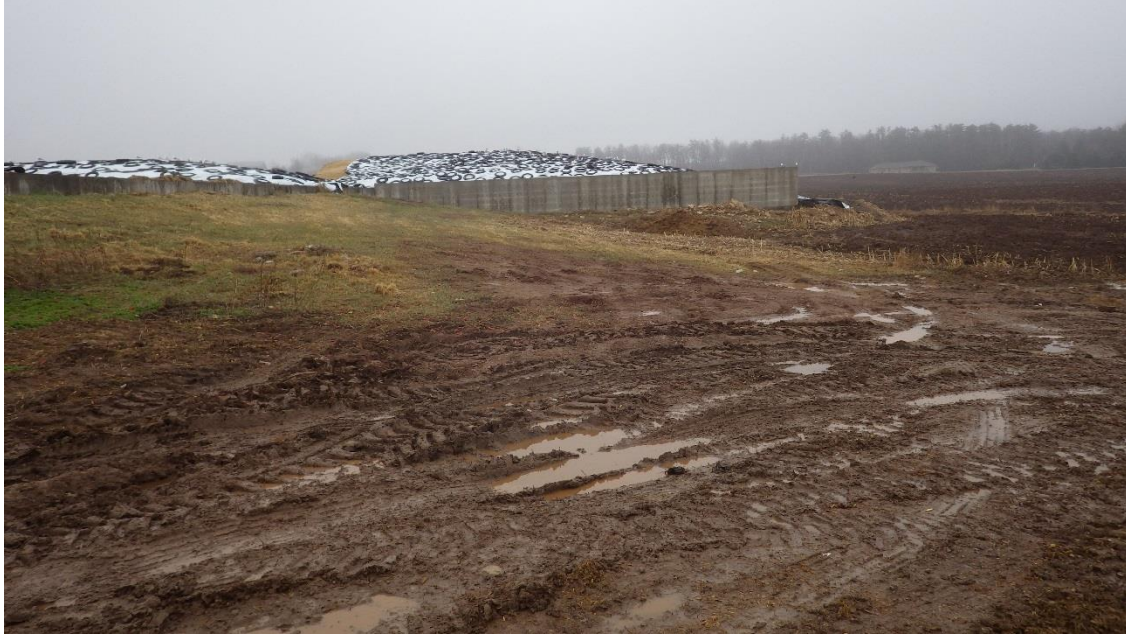
94: RIMG0103

Description: Feed and process wastewater had no containment along the south end of Lot D.

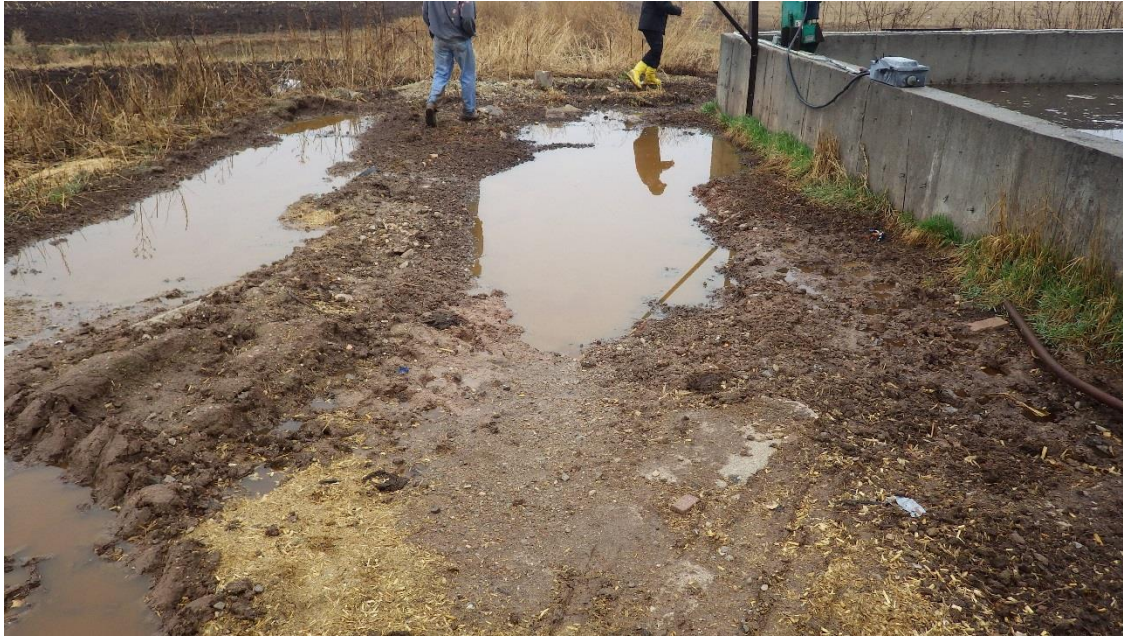
96: RIMG0105

Description: Feed and process wastewater had no containment along the south end of Lot D.

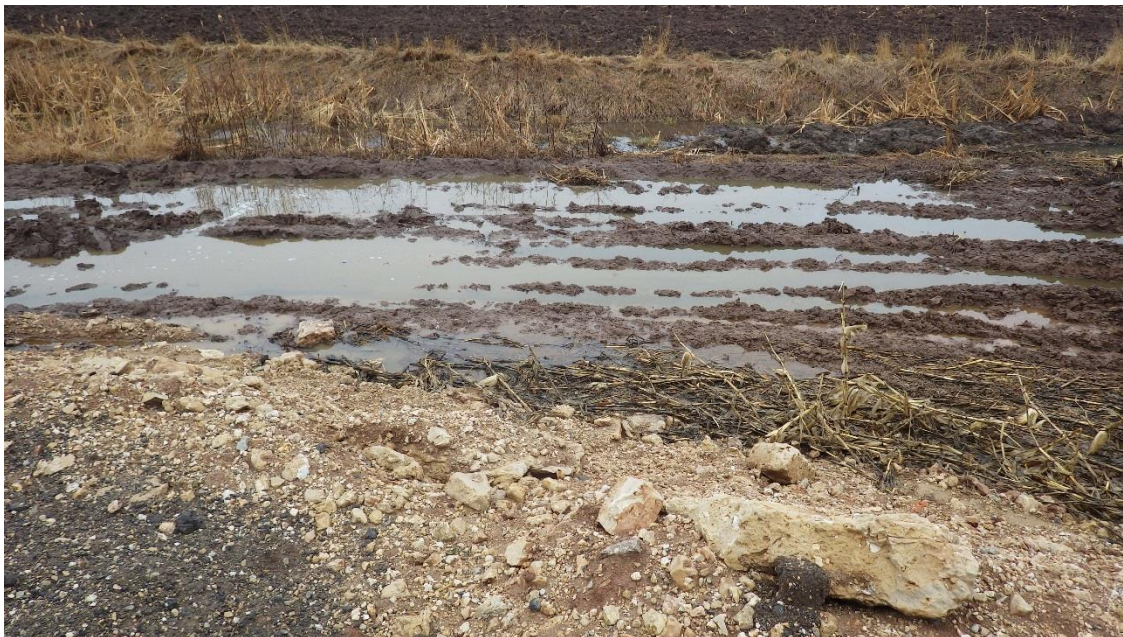
103: RIMG0112

Description: Unnamed tributary is located less than 50 feet from the edge of newly constructed bunker.

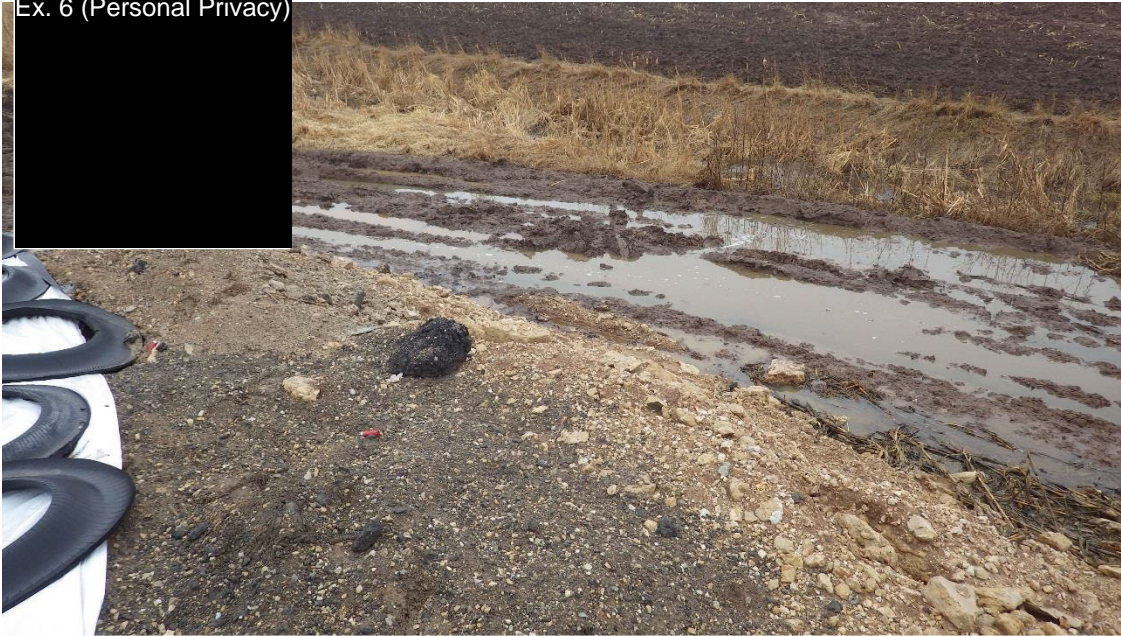
104: RIMG0113

Description: Unnamed tributary is located less than 50 feet from the edge of newly constructed bunker.

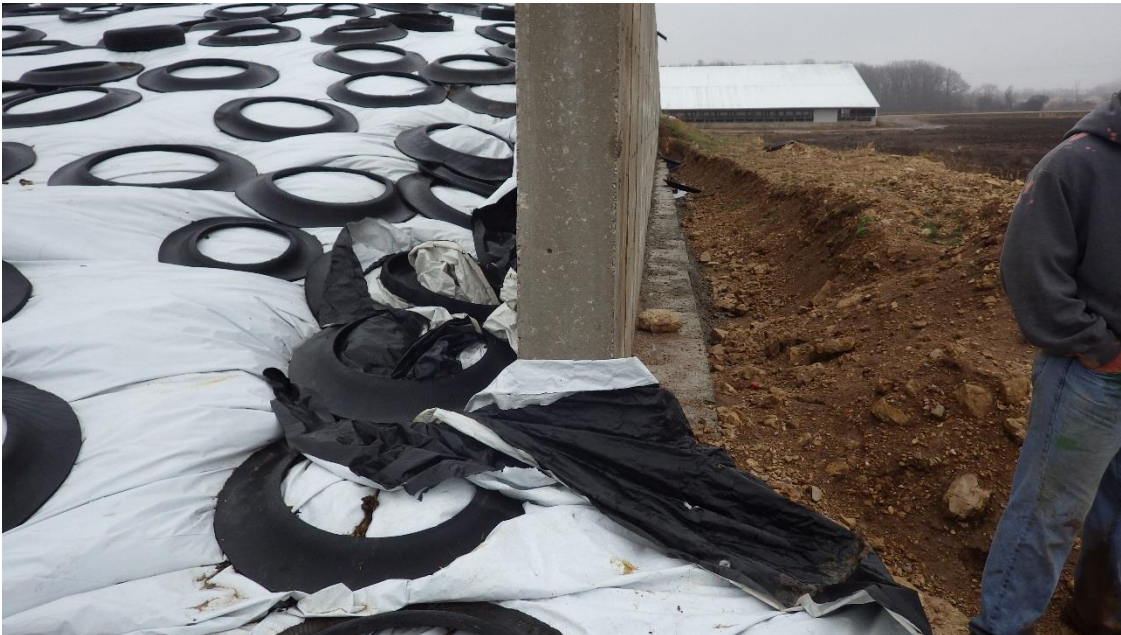
105: RIMG0114

Description: Unnamed tributary is located less than 50 feet from the edge of newly constructed bunker.

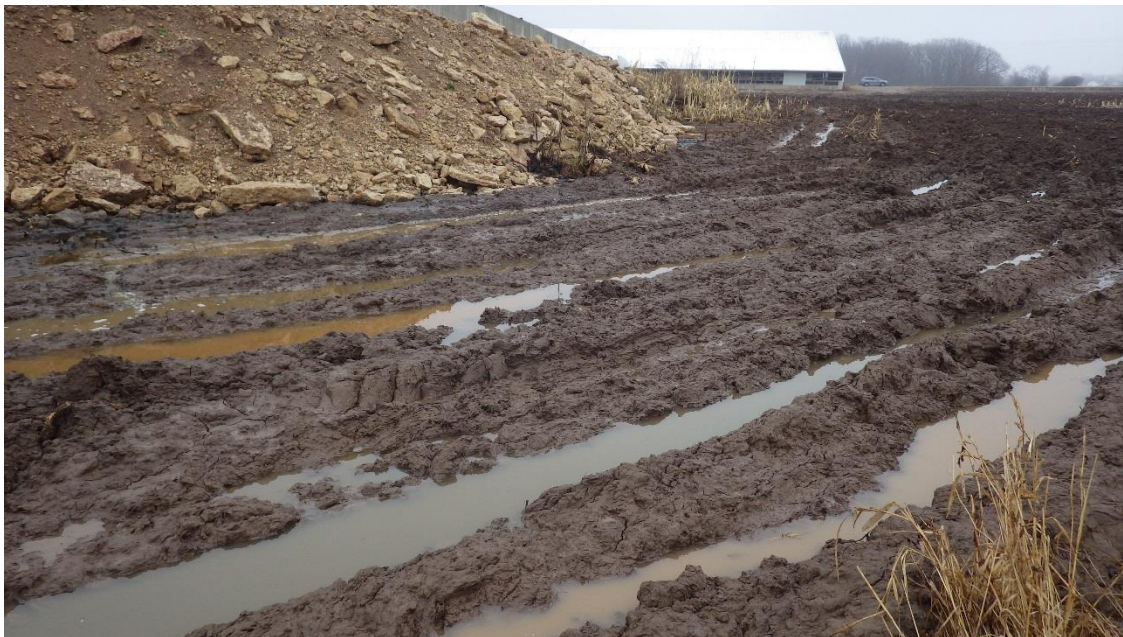
107: RIMG0116

Description: Leachate was seeping out through the rock/soil and then draining overland to the unnamed tributary.

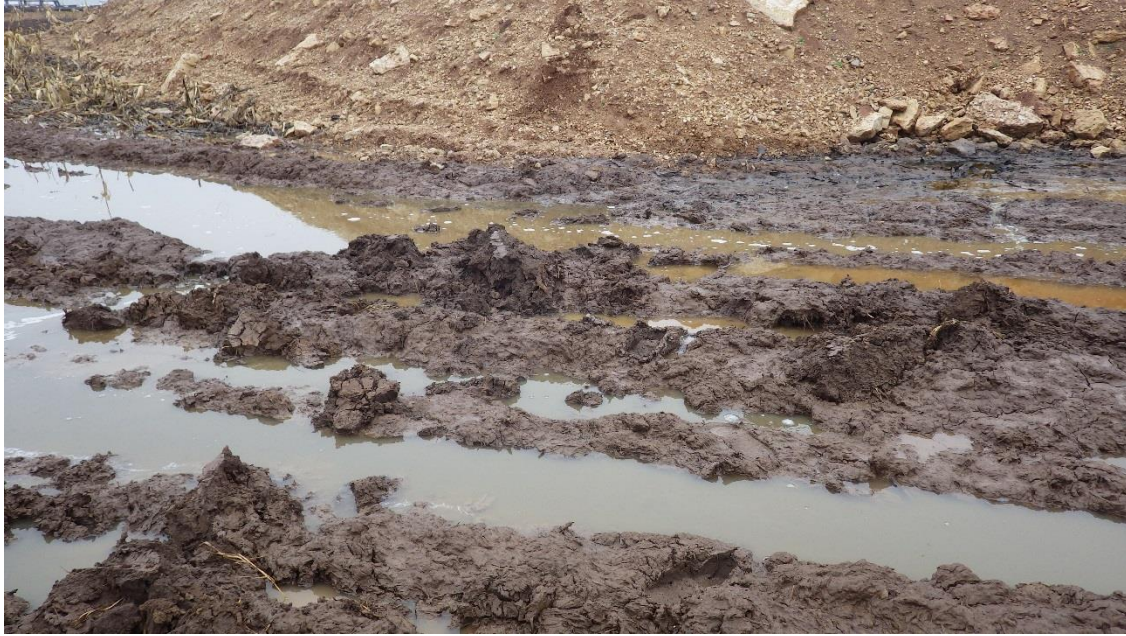
108: RIMG0117

Description: The leachate was draining west through tire ruts and into the unnamed tributary.

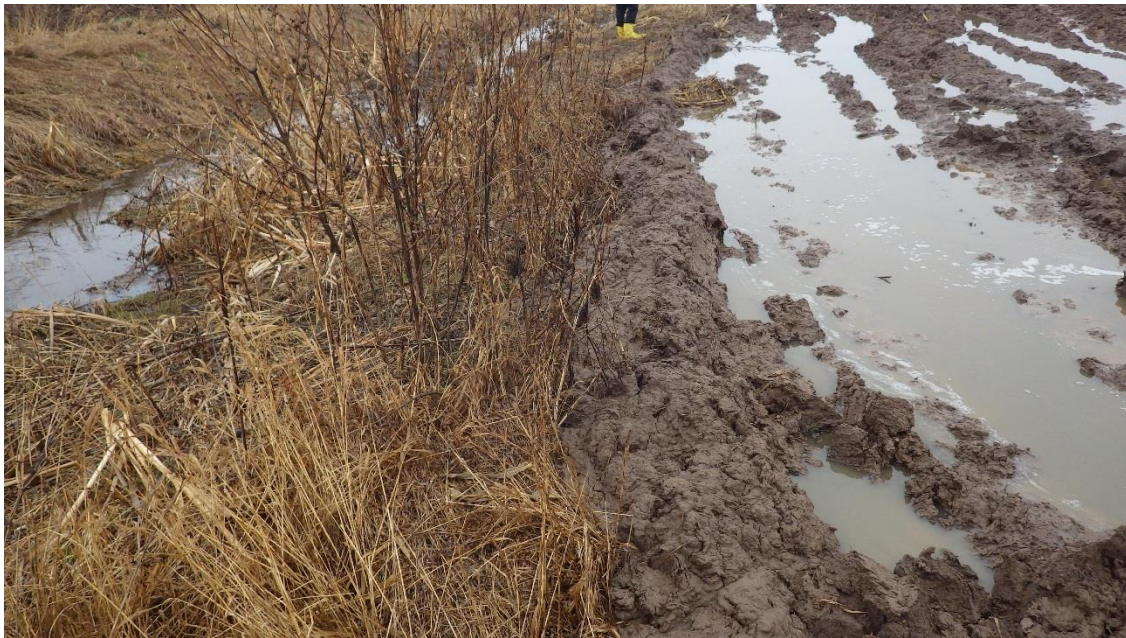
109: RIMG0118

Description: The leachate was draining west through tire ruts and into the unnamed tributary.

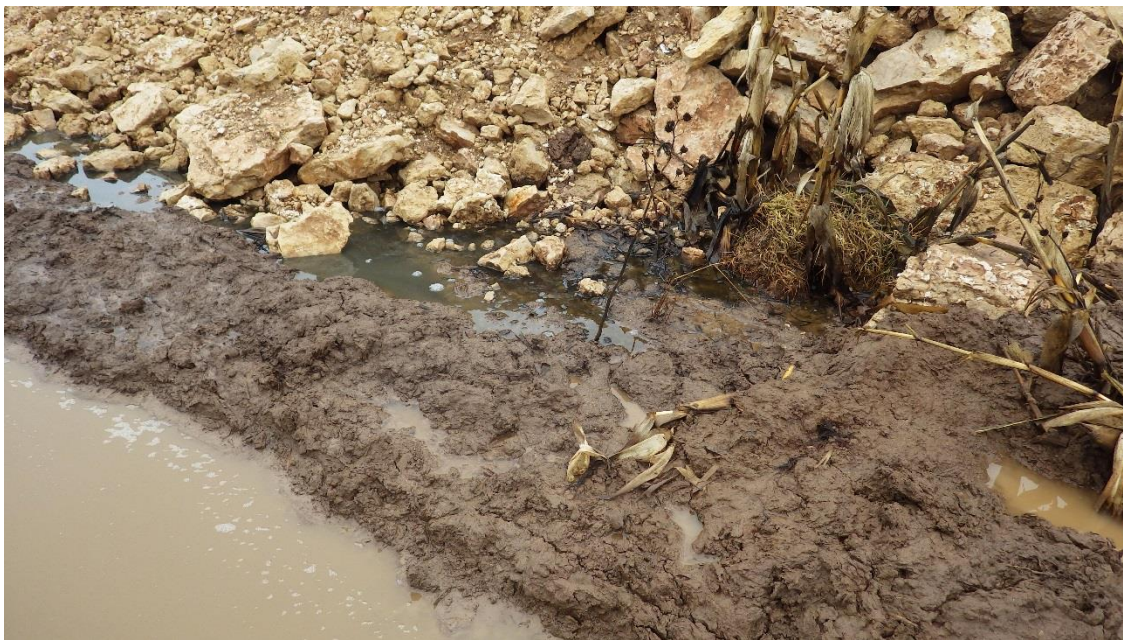
117: RIMG0126

Description: The leachate flowed through the tire ruts to the unnamed tributary.

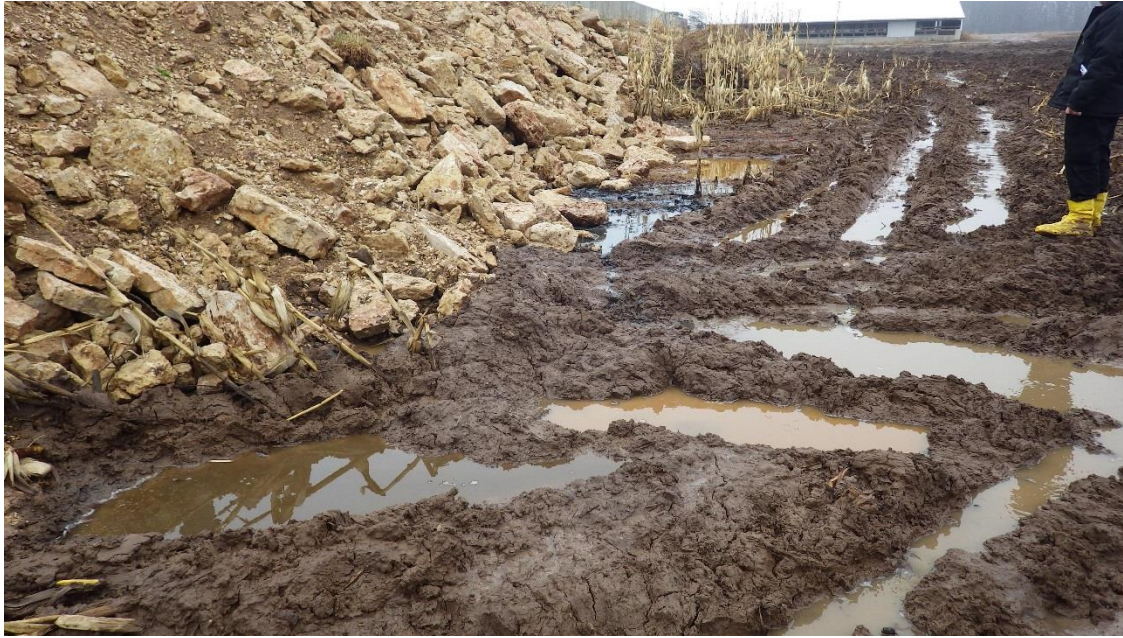
118: RIMG0127

Description: The leachate was seeping out of the rock/soil.

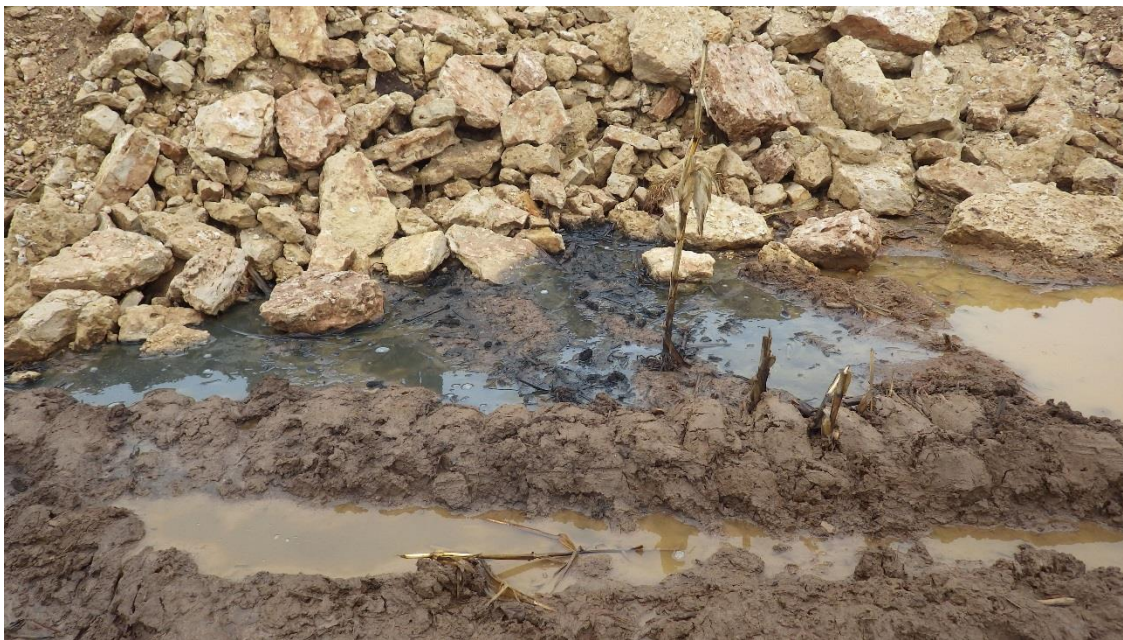
119: RIMG0128

Description: The leachate was seeping out of the rock/soil.
